GoPro Hero3+ Black Edition Image Sensor Replacement

Inside the device and behind the lens lies a Sony IMX117 image sensor. The following guide will illustrate the steps to replace this vital component.

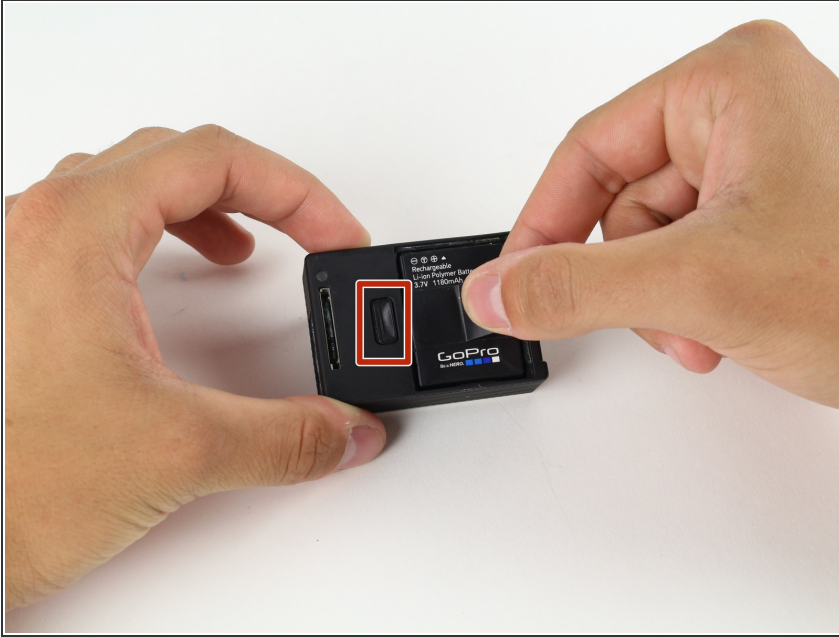
Step 1 — Battery

- Pull the tab on the back of the device to release the back cover. It should come right off.
- ⓘ The device pictured does not include the back cover.

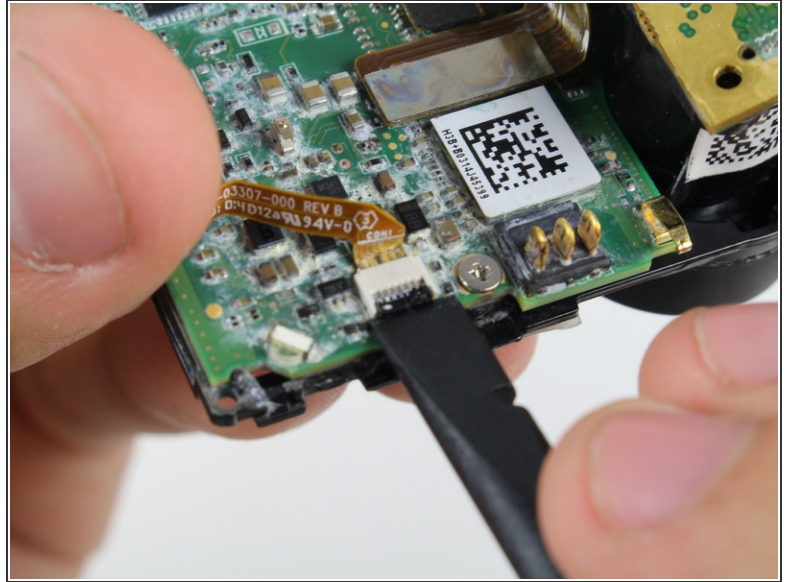
Step 5

- Remove the ribbon cable connecting the housing to the motherboard by flicking up the black clip with the spudger tool and gently pulling the cable out.
